Predicting roadheaders

Problems with the accurate prediction of excavation rates in soft and hard rock include geological difficulties leading to high bit consumption and the low cutting performance of roadheaders. K Thuro and R J Plinniger, Department of General, Applied & Engineering Geology, Technical University of Munich, examine the connection between geological features, cutting performance and bit wear through four German case histories in different geological settings.

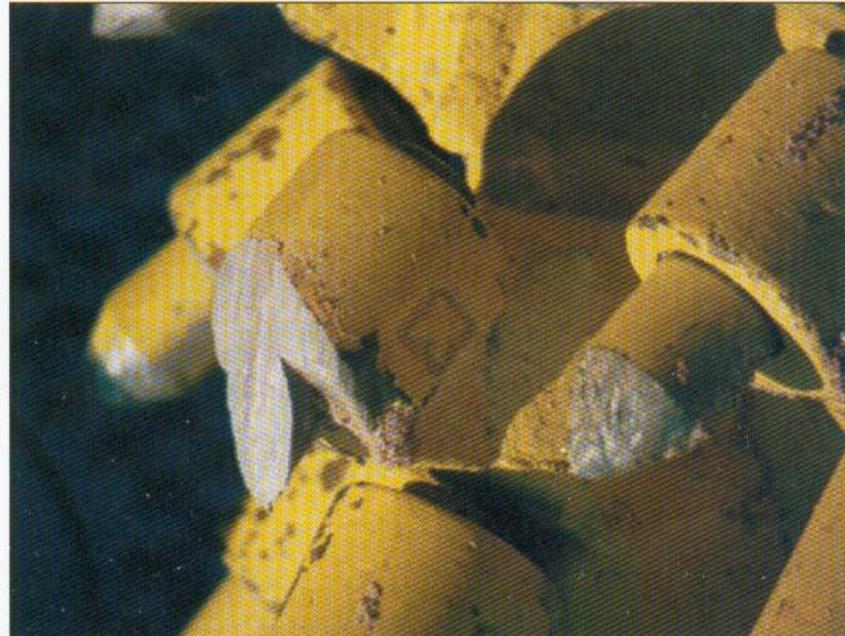
Typical asymmetric wear of the outer cutterhead bits of the Atlas Copco Eickhoff 300kW roadheader used on the Altenbergtunnel

In order to choose an economic tunnelling method, a test excavation with an Atlas Copco Eickhoff 300kW roadheader with a cross cutterhead was performed. The outer bits of the cutterhead were worn off immediately when they penetrated the hard, quartzite bearing rock mass. The roadheader suffered not only from enormous bit consumption but also from an exceptionally poor penetration and cutting performance. Although the compressive strength of the fanglomerate is 20-80MPa, the hardest components (quartzites) reach 230MPa.
