# **Rock Mass Scale Effects on Tool Wear in Hardrock Tunneling – practically significant and scientifically neglected?**

**Dr.rer.nat. Ralf J. Plinninger, Diplom-Geologe (Univ.)**

**Dr.rer.nat. Jan Düllmann, M. Sc. (Geosciences)**

Dr. Plinninger Geotechnik

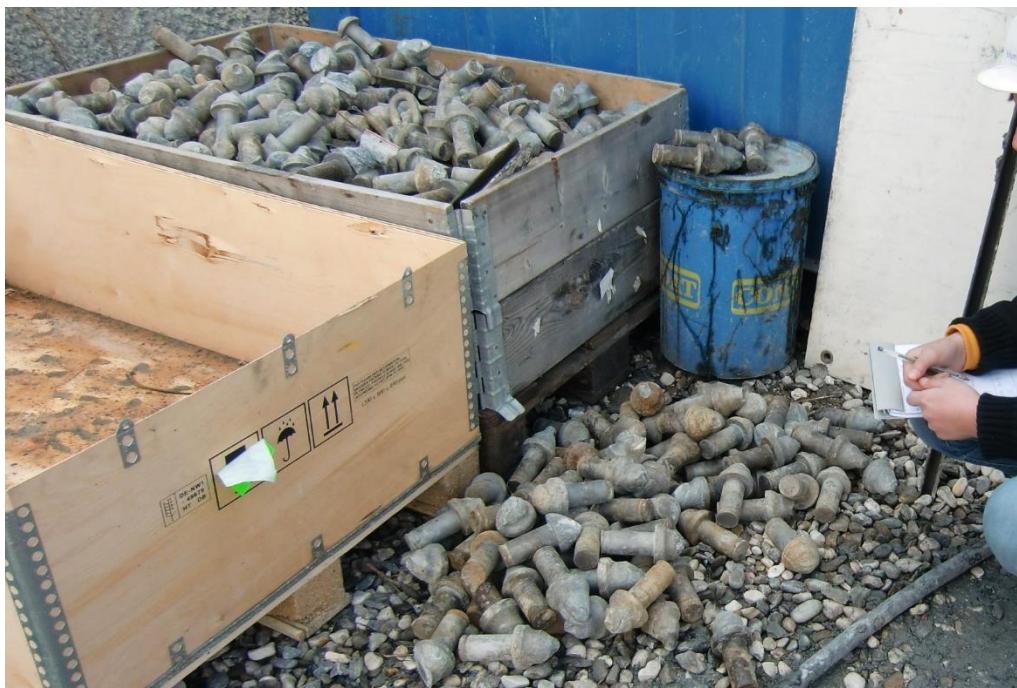
Fig. 2.1: Worn point attack picks of a roadheader, whose replacement was both caused by continuous abrasion, as well as partial failure of tool components (Photo: Plinninger).

This wear can be caused by various processes which usually do represent interactions between more continuous and abrading modes (→ "abrasive wear") and suddenly occurring events with more or less catastrophic failure of tool parts (→ "tool failure", see Fig. 2.1).

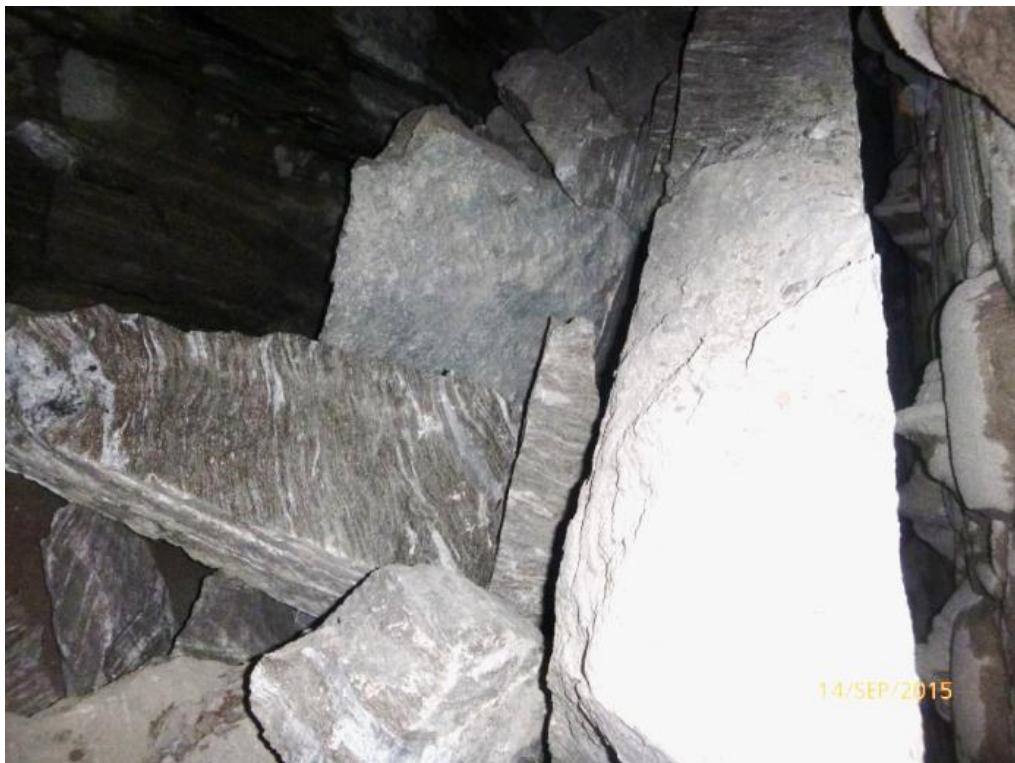
Fig. 3.5: Cubic decimetre to cubic meter large gneiss blocks in front of the cutterhead of a hard rock TBM. Discs and cutterhead can be seen on the right edge of the image (Photo: Plinninger).

The terms of an "unstable", "collapsing", "blocky" face or "blockiness" describe conditions in mechanized tunneling, where the rock mass collapses at the face in front of the cutterhead, forming larger rock bodies besides or instead of the "normal" rock chips that form during cutting (see for instance Austrian Standard ÖNORM B2203-2). Such rock blocks or plates can reach significant sizes of up to several cubic meters (see Fig. 3.5).

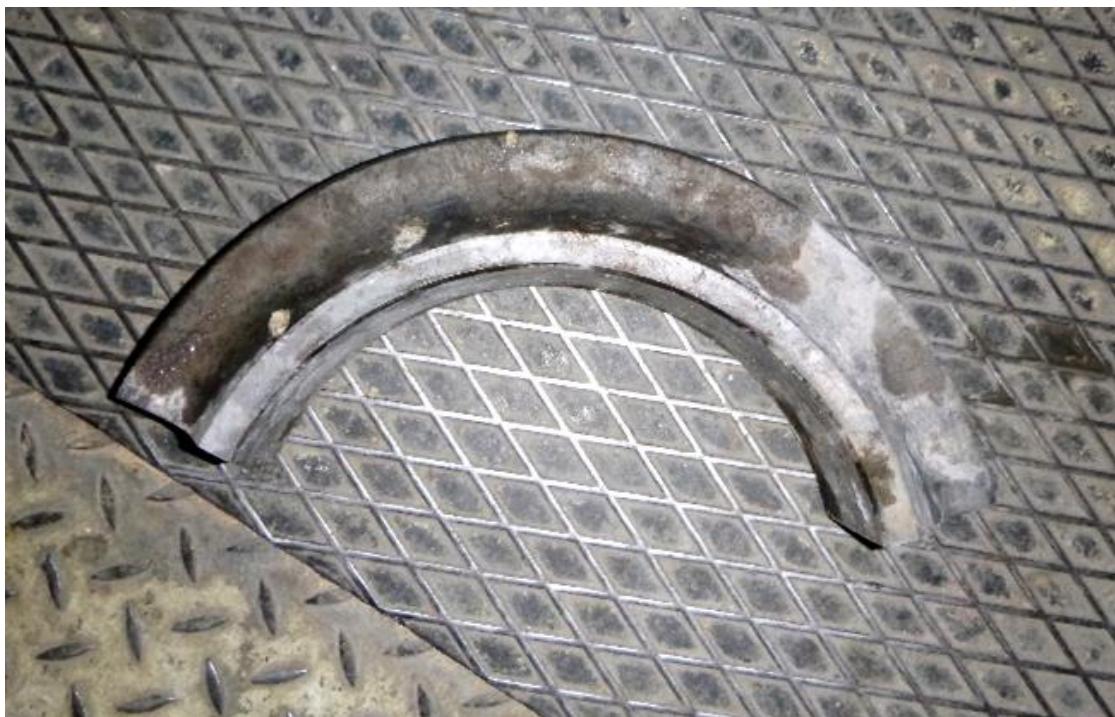
Fig. 4.2: Broken 17"-cutter disc of a hardrock TBM (Photo: Plinninger).

Homogeneous steel tools, as for instance disc cutters or steel bodies of drill bits and point attack picks can also be affected by brittle material failure - although steel is able to perform significantly tougher than hard metals. Such phenomena, for instance fracturing of disc cutters (see Fig. 4.2) have to be rated as one the most expensive problems during operation of a hardrock TBM.
